Facility and Development Committee Agenda

2. Franklin Middle School Inspection Report

Commercial Inspection

Inspected on Fri, May 5 2023 at 11:17 AM

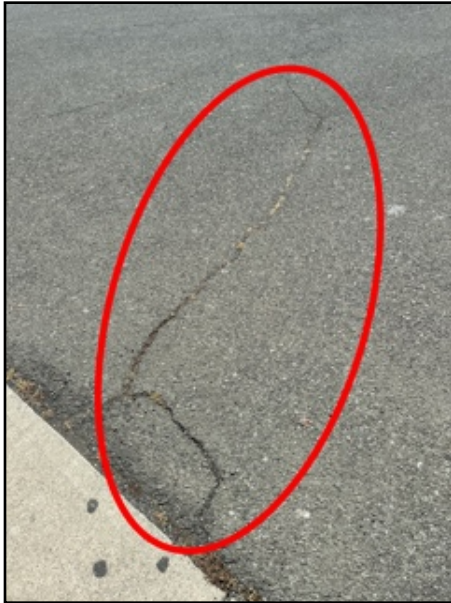
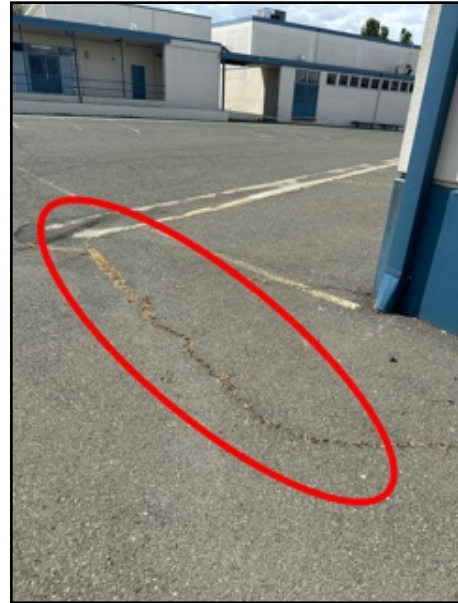
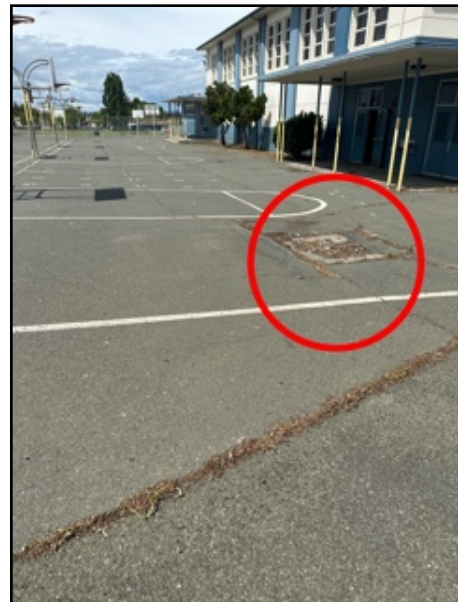
Walk ways have minor cracks and moisture entry points , around the perimeter,that can cause greater damage over time. Recommend licensed professional for repairs.

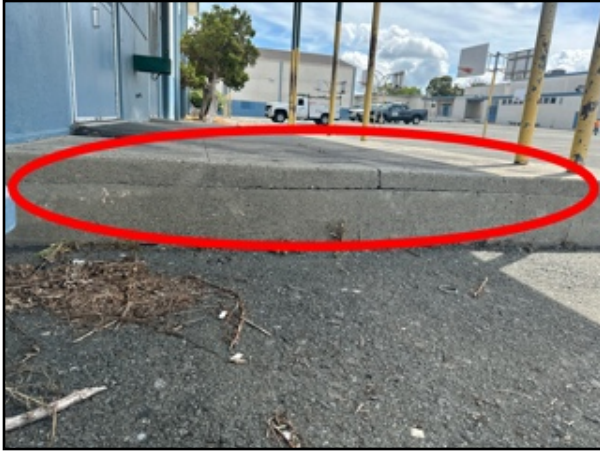
Figure 3-1

Concrete patio foundation has a horizontal crack from one into the other. Recommend a licensed professional for further evaluation and repairs to further extend the life expectancy of the concrete patio.

1) Concrete patio foundation has a horizontal crack from one into the other. Recommend a licensed professional for further evaluation and repairs to further extend the life expectancy of the concrete patio.

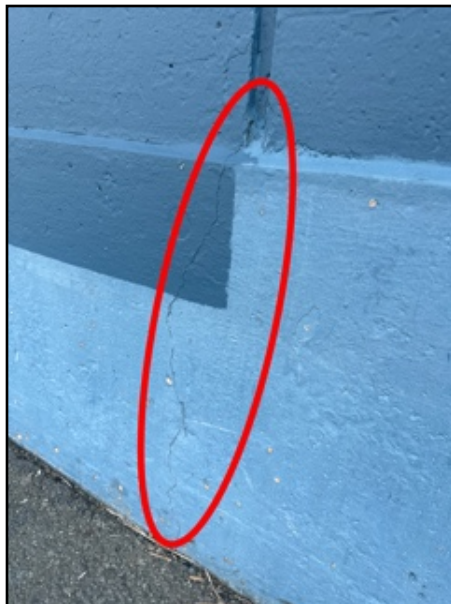
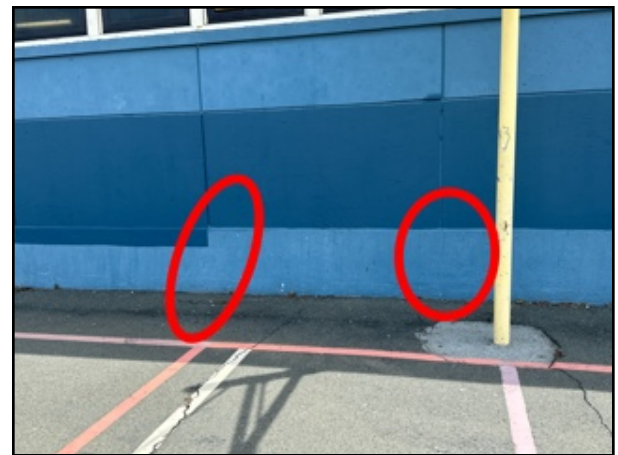
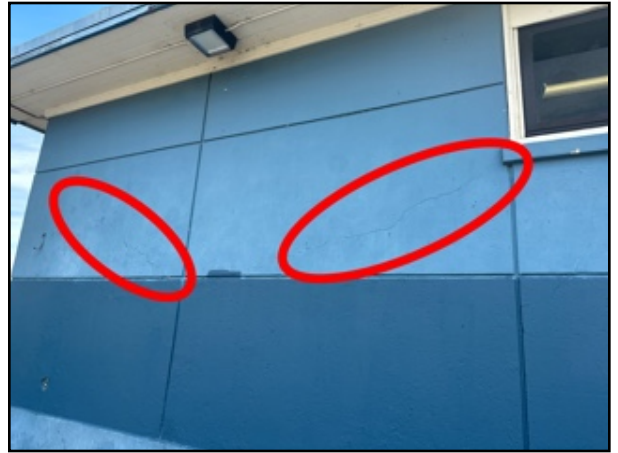
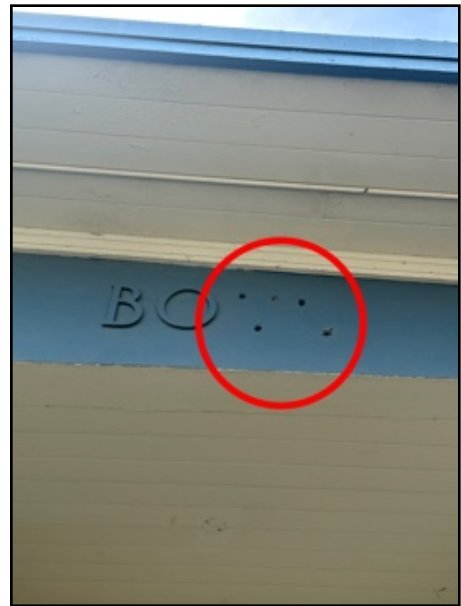
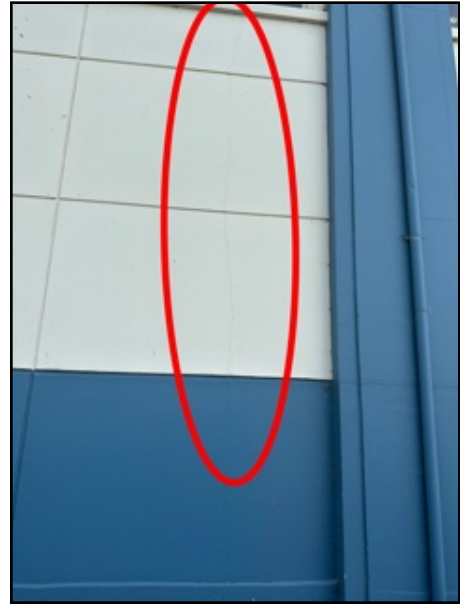
Minor cracking and previous repairs made to cracks were observed. Recommend sealing and monitoring. If conditions worsen refer to structural engineer for further evaluation and remedy of repair

2) Minor cracking and previous repairs made to cracks were observed. Recommend sealing and monitoring. If conditions worsen refer to structural engineer for further evaluation and remedy of repair

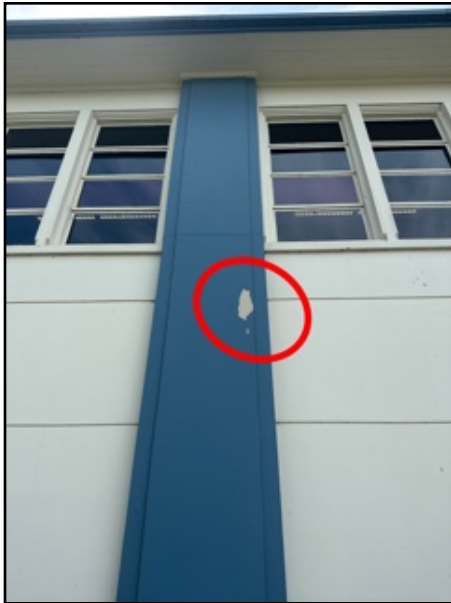
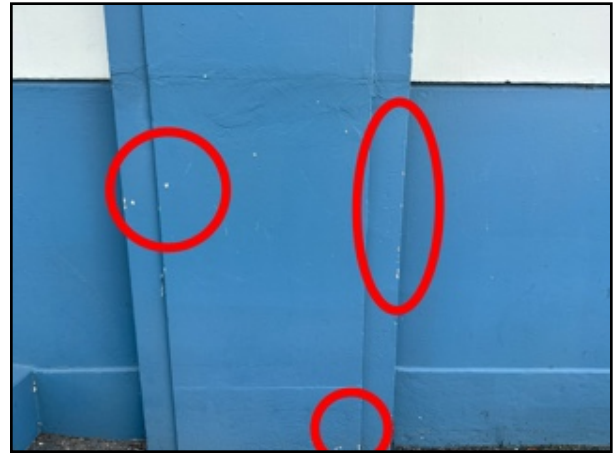
Some areas have lost paint over time. Recommend licensed painter for painting to ensure longevity.

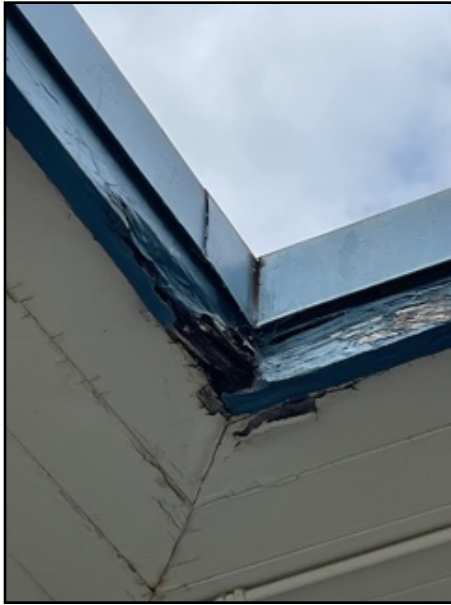
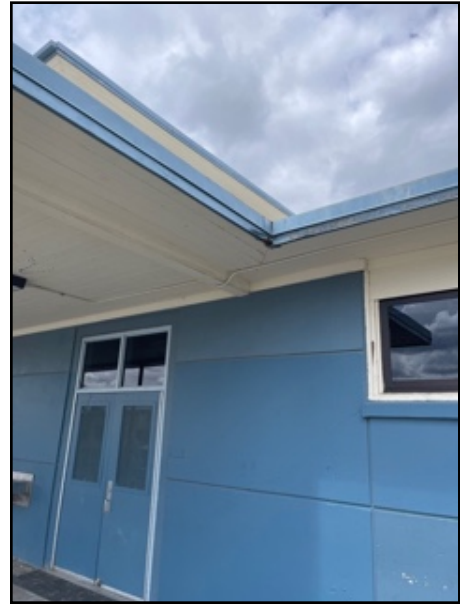
Dry rot located. Recommend licensed professional for removal and replacement of damaged areas to prevent further issues

3) Dry rot located. Recommend licensed professional for removal and replacement of damaged areas to prevent further issues

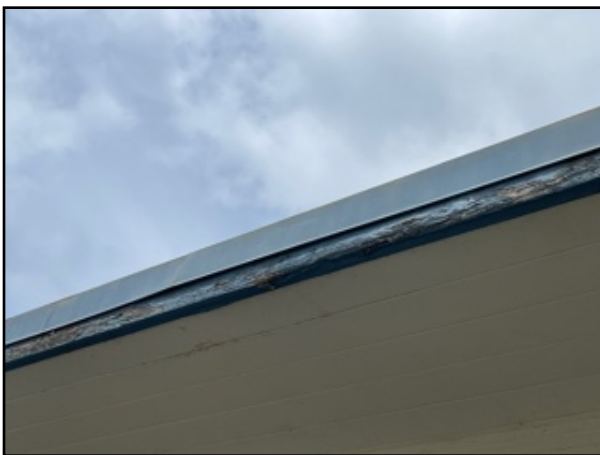
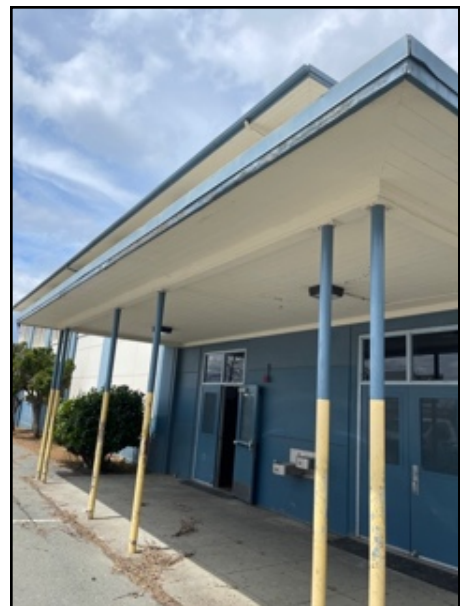
Recommend sealing all cracks and repainting parts of trim that have lost paint by a licensed professional. This will retain the life of the wood and help prevent dry rot in the future

4) Recommend sealing all cracks and repainting parts of trim that have lost paint by a licensed professional. This will retain the life of the wood and help prevent dry rot in the future

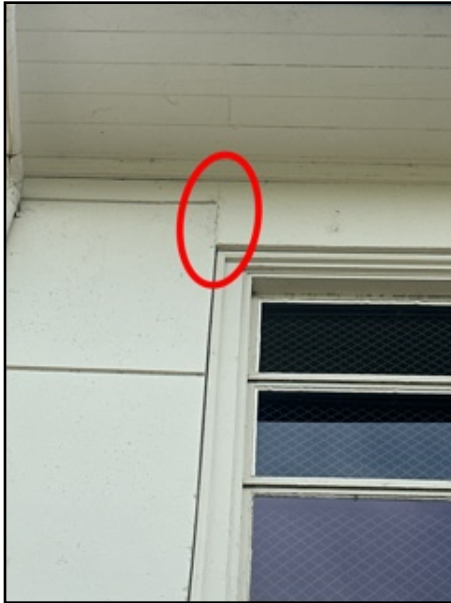
Figure 9-1

Cracks and openings in window exterior trims are potentially water entry points. recommend licensed professional for repairs. This is a possible sign of foundation settling .

5) Cracks and openings in window exterior trims are potentially water entry points. recommend licensed professional for repairs. This is a possible sign of foundation settling .

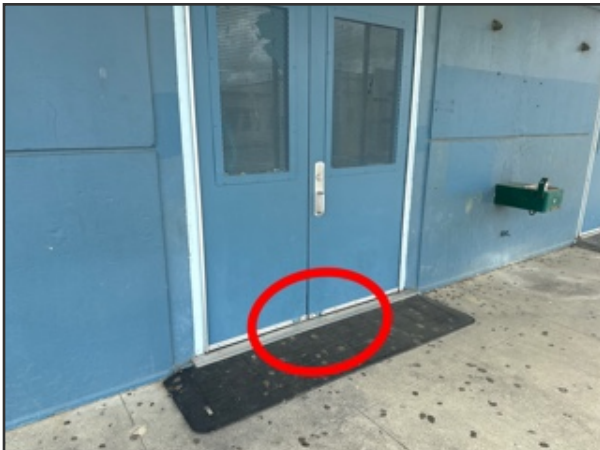
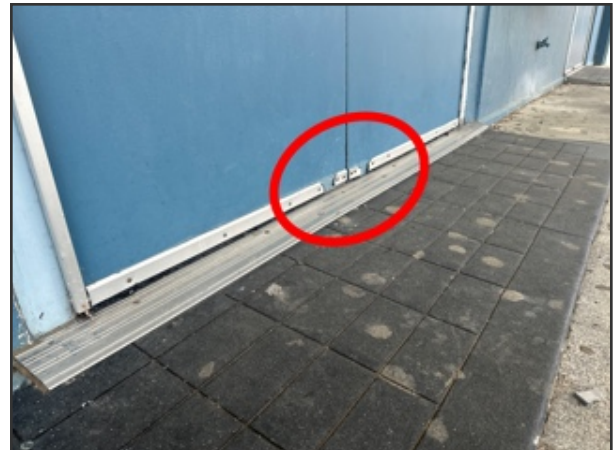
Weatherstrip bar on the base of some of the gymnasium steel doors are damaged. Recommend licensed professional for repairs and replacement.

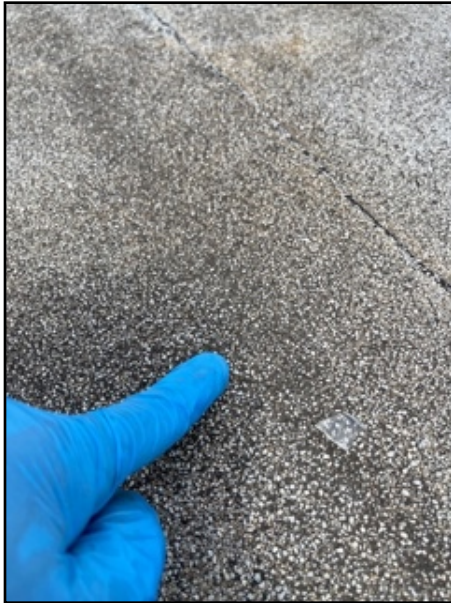
Figure 11-1

Granular loss within material. This is the material fixed to covering that protects from outside elements. Recommend licensed professional for replacement to ensure no leaks are present in the future

6) Granular loss within material. This is the material fixed to covering that protects from outside elements. Recommend licensed professional for replacement to ensure no leaks are present in the future

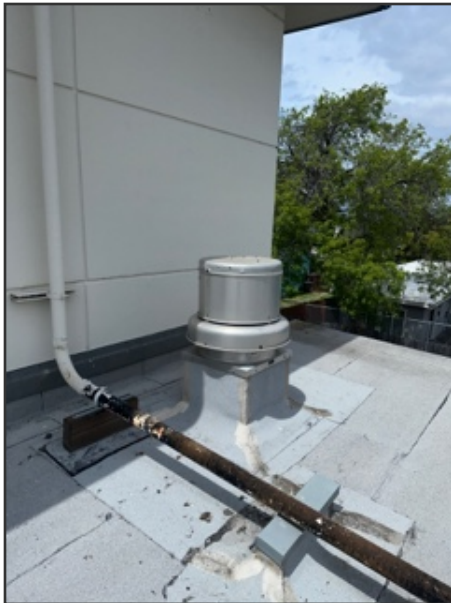
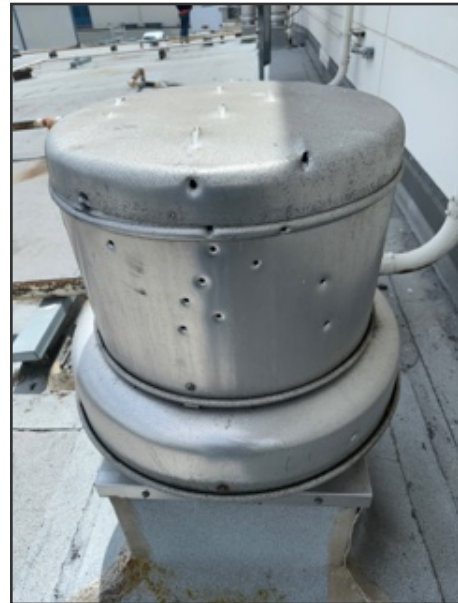
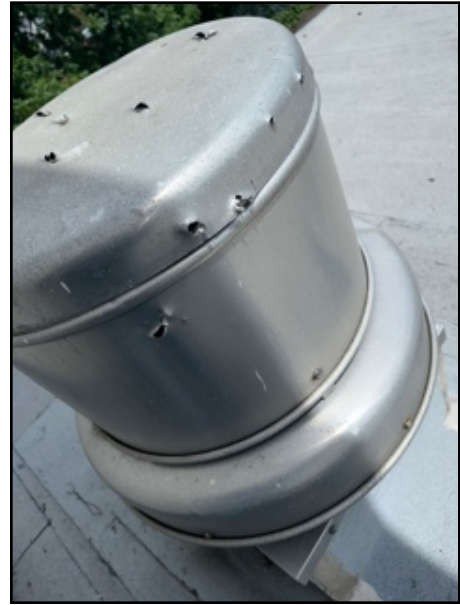
Vent stack on the roof on the right side of the building has bullet holes riddled through it. Recommend a licensed professional for replacement .

7) Vent stack on the roof on the right side of the building has bullet holes riddled through it. Recommend a licensed professional for replacement .

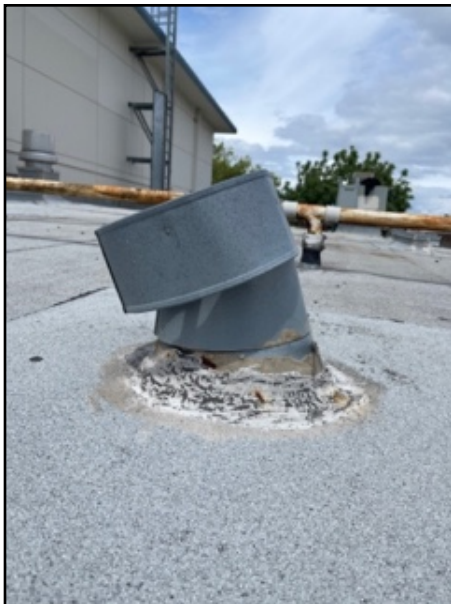
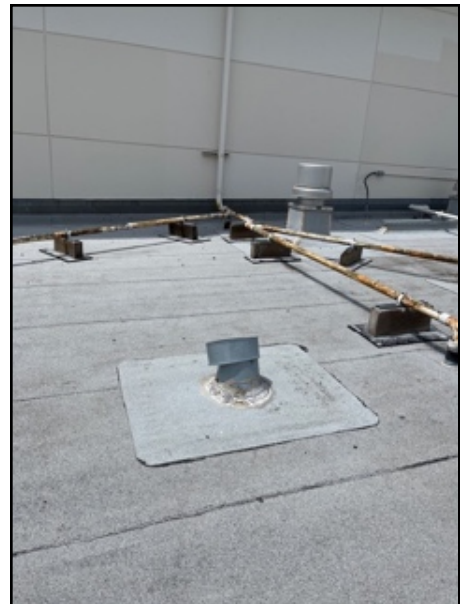
Vent stack is damaged recommend replacement.

8) Vent stack is damaged recommend replacement.

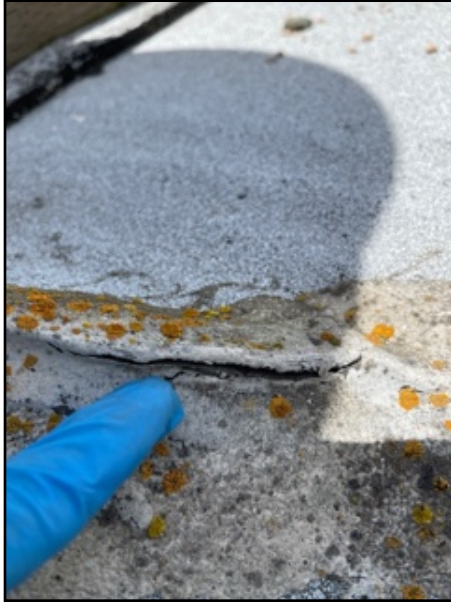
Figure 14-1

Flashing cracked and not sealed around vents/stack/siding. Recommend a licensed professional to perform general roof maintenance.

9) Flashing cracked and not sealed around vents/stack/siding. Recommend a licensed professional to perform general roof maintenance.

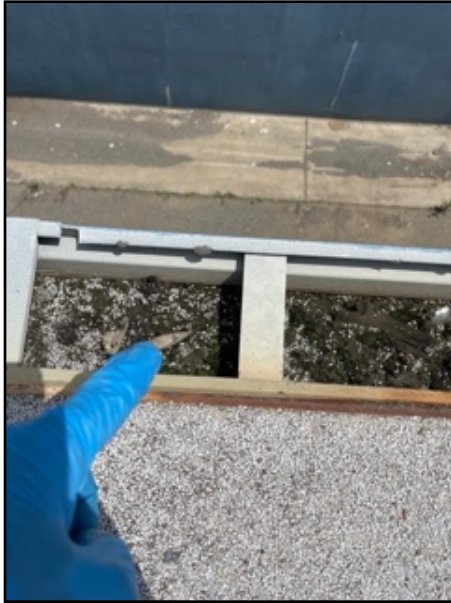
Figure 15-1

Recommend a licensed professional to service and clean gutters.

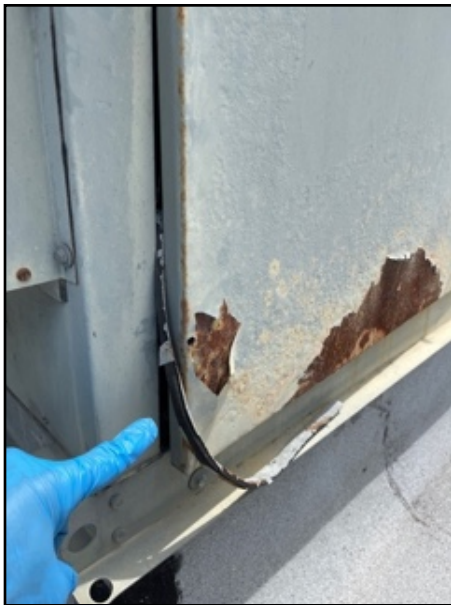
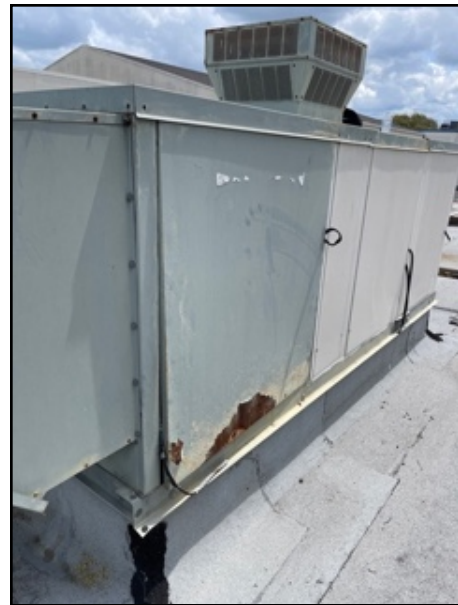
Protective covering is rested and not sealed properly recommend repair or replacement to prevent moisture intrusion's within the system.

11) Protective covering is rested and not sealed properly recommend repair or replacement to prevent moisture intrusion's within the system.

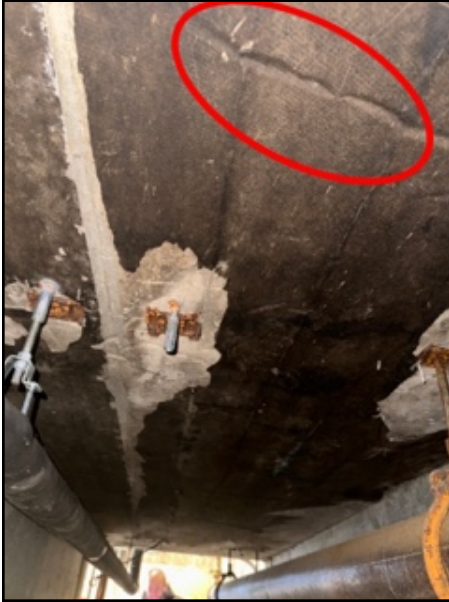
Figure 22-1

Plumbing Corridor ceiling has multiple cracks throughout the base of the concrete slab. Recommend structure waiting to hear for further evaluation.

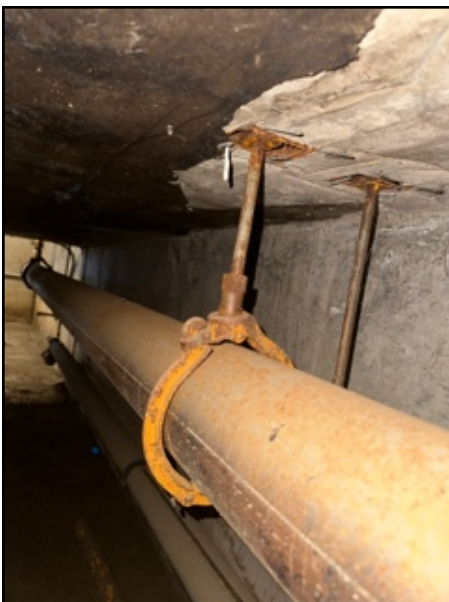
Figure 23-1

Pipeline mounts are rusted ,corroded and some are cracked. Recommend license, professional for repairs and replacement.

12) Pipeline mounts are rusted ,corroded and some are cracked. Recommend license, professional for repairs and replacement.

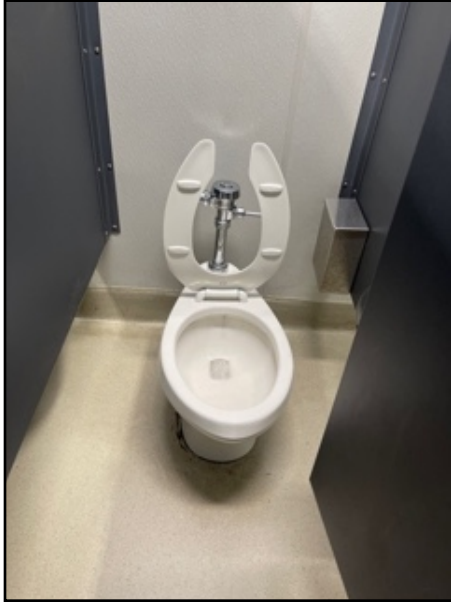
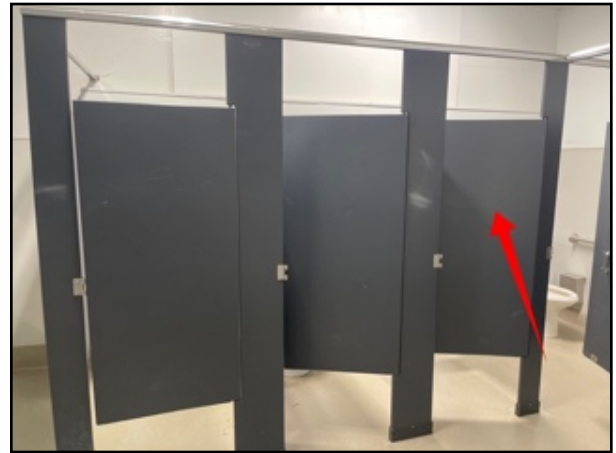
Toilet is loose. Recommend resealing/fixing toilet to flooring. This will prevent moisture access points and damages to wax seal while operating

14) Toilet is loose. Recommend resealing/fixing toilet to flooring. This will prevent moisture access points and damages to wax seal while operating

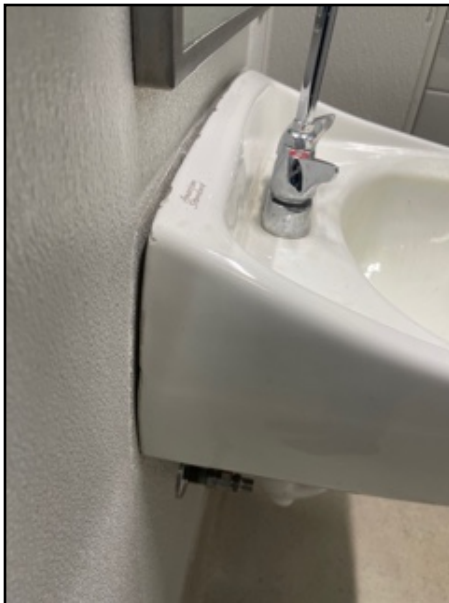
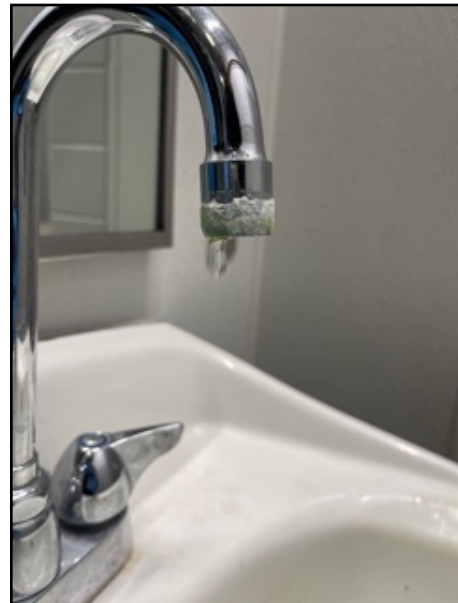
Sink continuously runs when not in use. Sink is loose against wall. Recommend repair

15) Sink continuously runs when not in use. Sink is loose against wall. Recommend repair

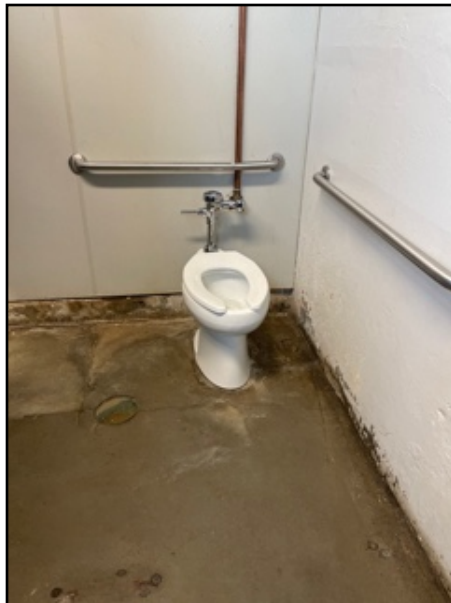
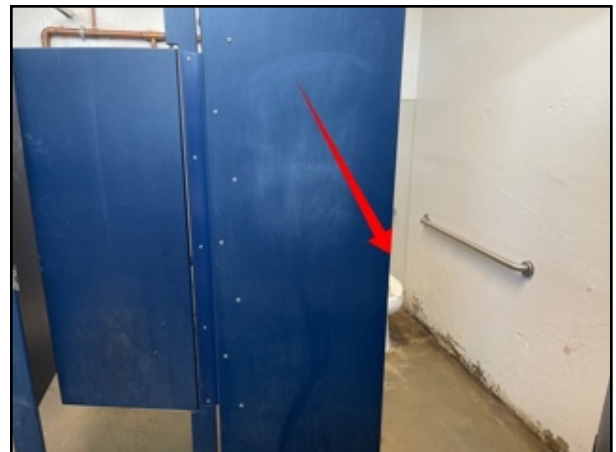
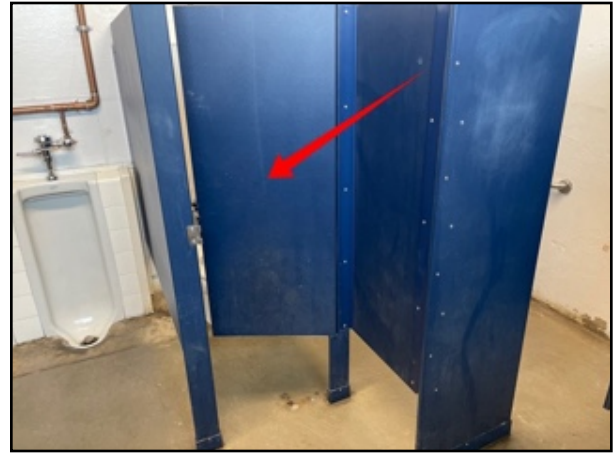
Toilet is loose. Recommend resealing/fixing toilet to flooring. This will prevent moisture access points and damages to wax seal while operating

16) Toilet is loose. Recommend resealing/fixing toilet to flooring. This will prevent moisture access points and damages to wax seal while operating

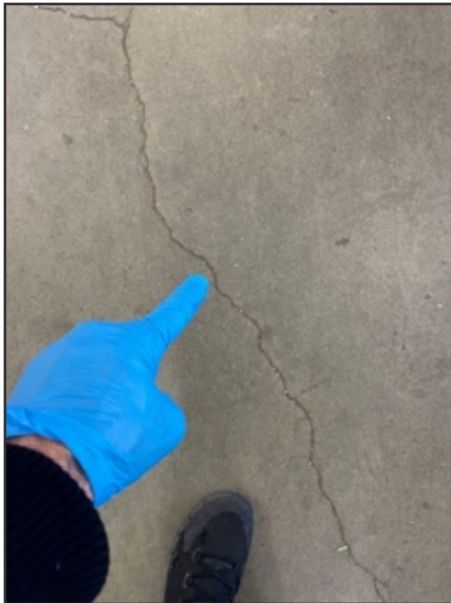
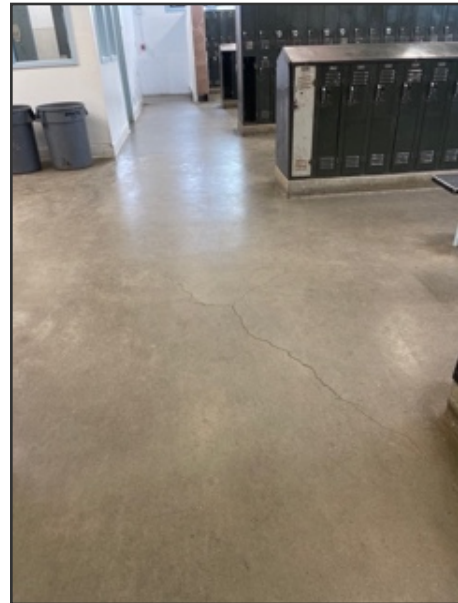
Minor cracking observed at floor/floor slab. Recommend monitoring carefully. If conditions worsen refer to a structural engineer for further evaluation

17) Minor cracking observed at floor/floor slab. Recommend monitoring carefully. If conditions worsen refer to a structural engineer for further evaluation

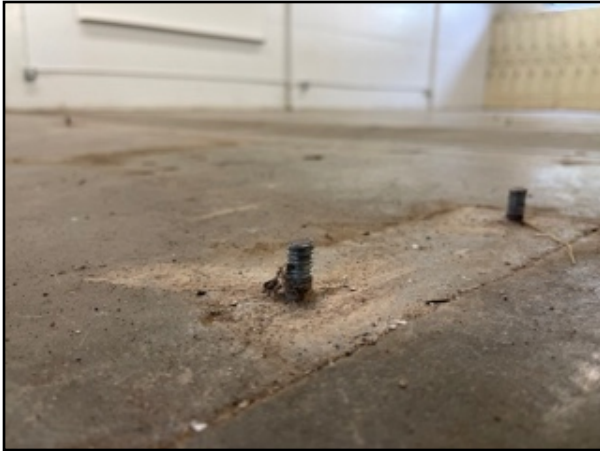
Figure 33-1

Potential tripping hazards within locker room. Bolts protruding throughout flooring

18) Potential tripping hazards within locker room. Bolts protruding throughout flooring

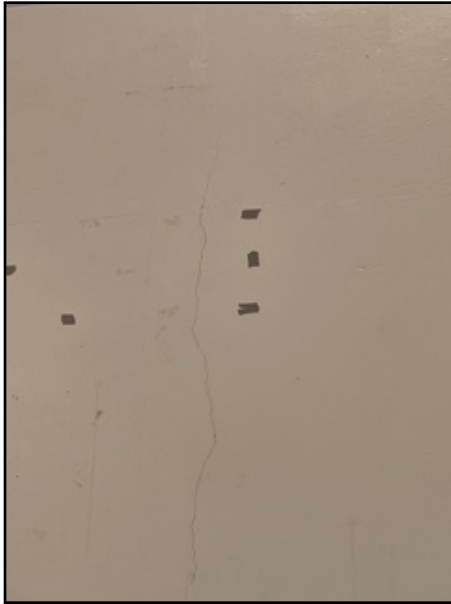
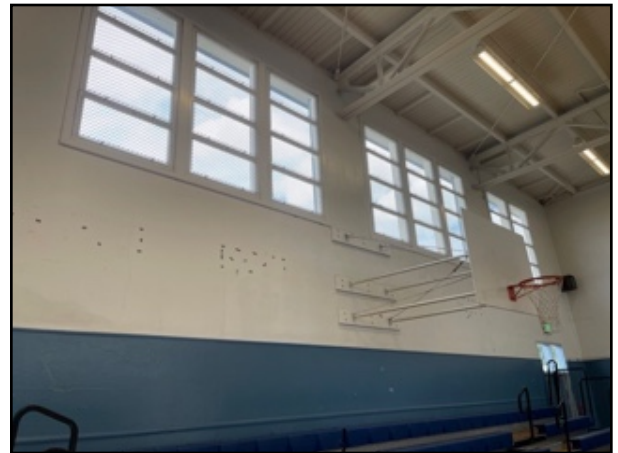
Cracks over door/window frames noted at time of inspection. This is a sign of settling within the foundation. Although settling is common, we advise you keep an eye on them to ensure there is no growth or new occurrences throughout the structure over time

19) Cracks over door/window frames noted at time of inspection. This is a sign of settling within the foundation. Although settling is common, we advise you keep an eye on them to ensure there is no growth or new occurrences throughout the structure over time

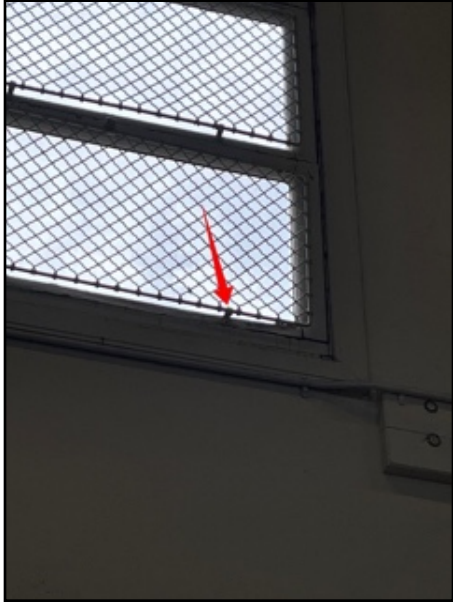
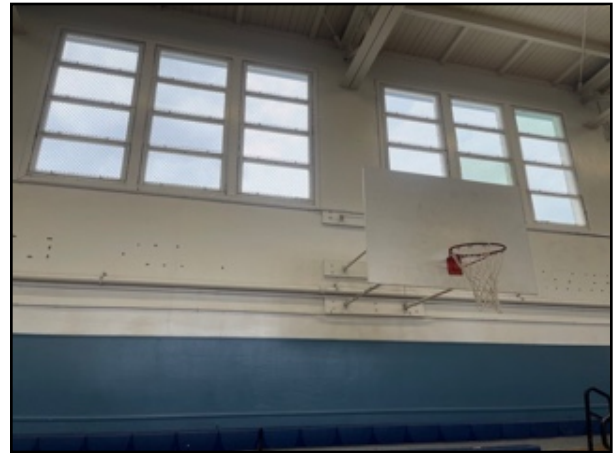
Comment 35:
Wood rot located on multiple window framings near basketball court.
Recommend removal and replacement

20) Wood rot located on multiple window framings near basketball court. Recommend removal and replacement
