Facilities and Development Committee Agenda

AMERICAN COMPLIANCE SERVICES, LTD

ASBESTOS and LEAD BASED PAINT SURVEY

225 Amador Street
Vallejo, California

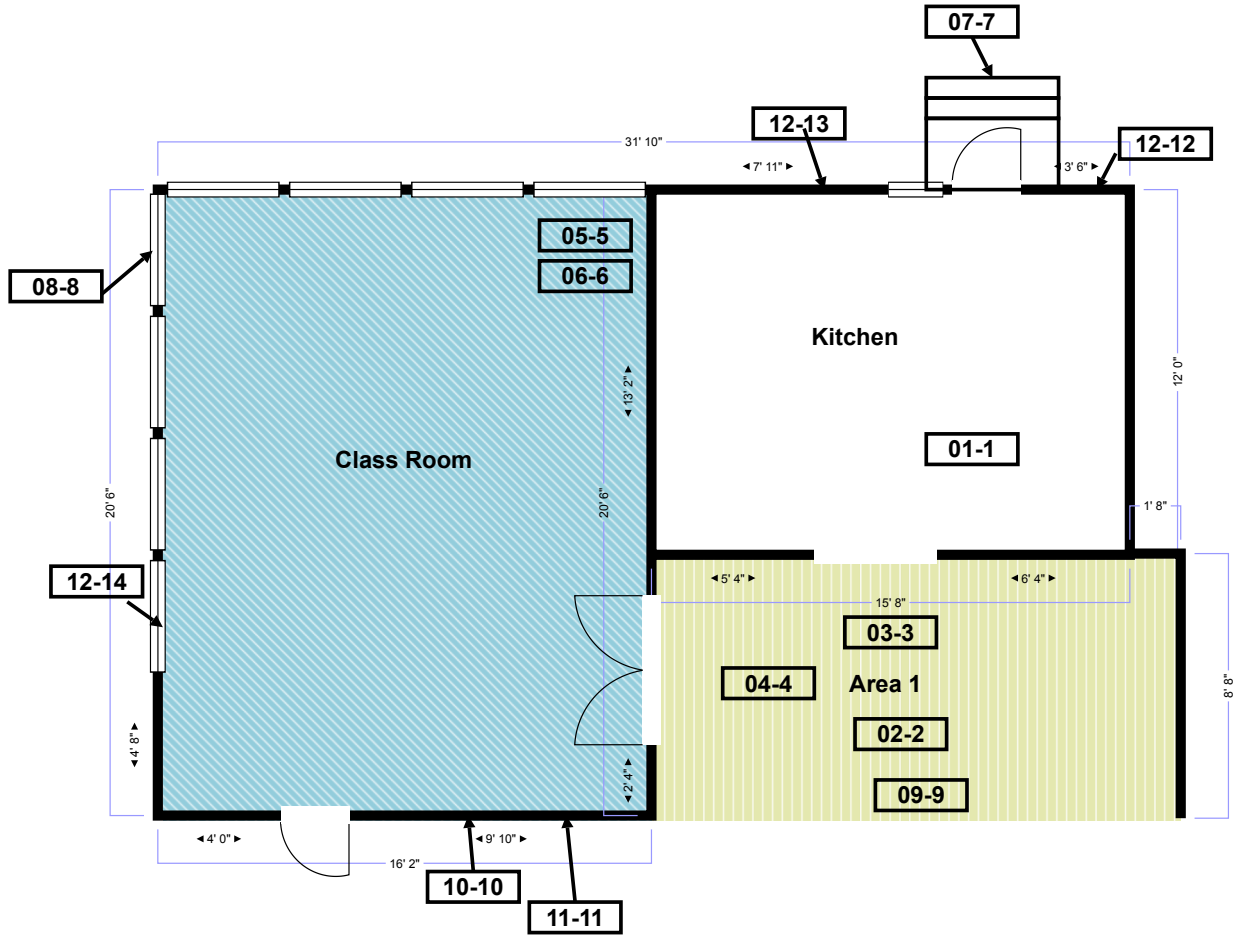
Asbestos Plan
 225 Amador Street
 Vallejo, California

- Carpet Mastic- Mastic: 8% CH
- 12x12 Floor Tile/ Mastic - Mastic: 5% CH

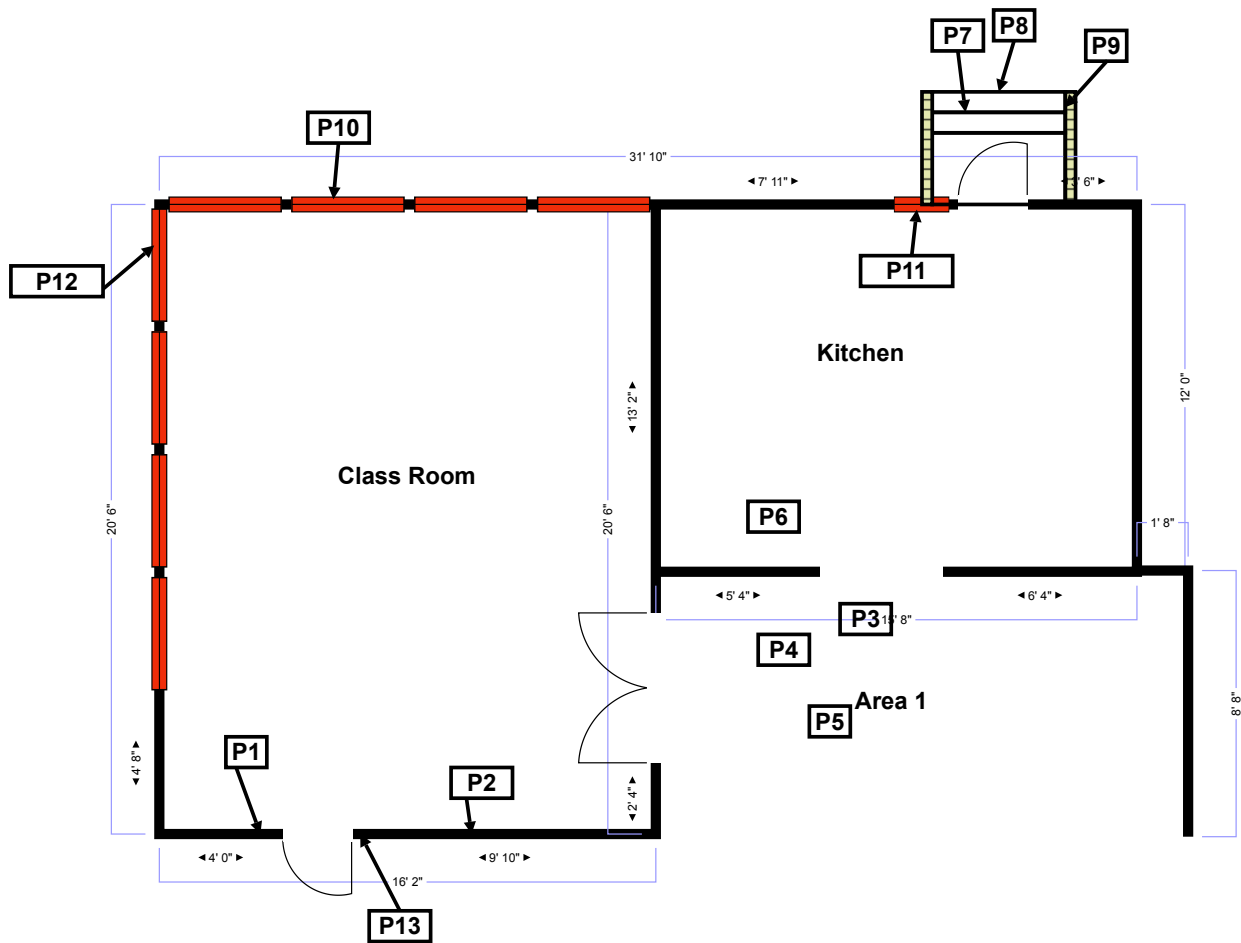
Lead Plan
 225 Amador Street
 Vallejo, California

Brown Paint on Windows - 13,000 ppm; Window Putty- 11,000 ppm

Green Paint on Handrail - 7,800 ppm

A lead notification to Cal-OSHA is required 24 hours prior to removing lead-based paint when disturbing 100 square or linear feet or greater. When the lead-based paint identified in this report will be disturbed through maintenance or demolition activities, the contractor must comply with the EPA and CDPH regulations that require containment of lead hazards so as not to create lead contamination and exposure to bystanders or the environment.

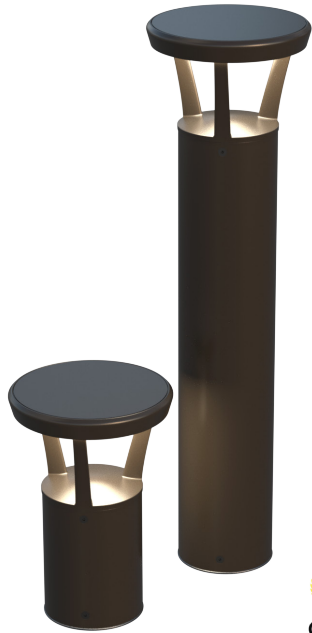
The PLB-AC Series high efficiency LED bollard is ideal for pathway, egress and public space lighting applications. The stylish, contemporary design makes it a perfect fit for any new construction, renovation, or retrofit project that requires exceptional, full cutoff lighting performance with maximum energy savings.

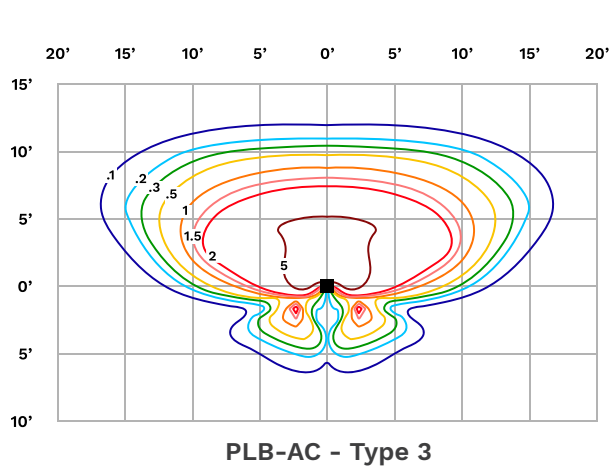
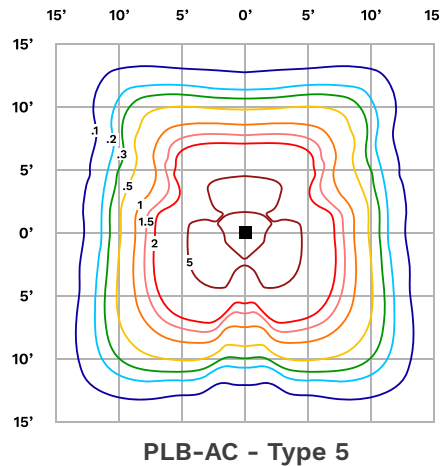
PHOTOMETRICS (IES files available on website)

- Photometrics based on PLB 102 mounting height
- All light levels in foot candles (fc) with 4000K color temperature
- To convert to lux multiply light level by 10.7
- Contact us for help in choosing the right lighting distribution
- Specifications subject to change without notice
