**GREATER VALLEJO
PARK & RECREATION
DISTRICT
Dan Foley Park;
Multi-Use Sports Field
Vallejo, CA**

Synthetic Turf Resurfacing & Renewal

FIELD OBSERVATION REPORT A

PROJECT: Dan Foley Park, Vallejo; Synthetic Field Resurfacing

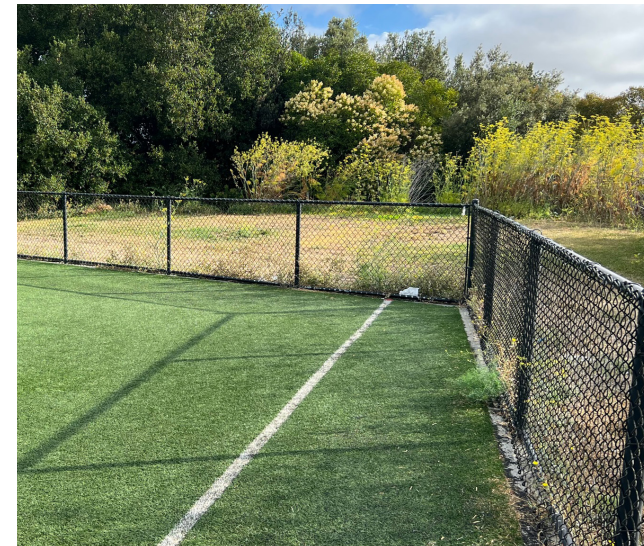
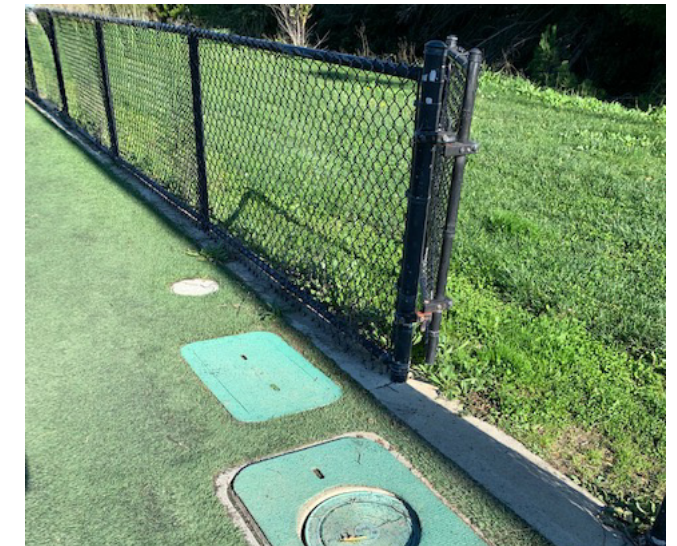
The existing synthetic playing surface, approximately 103,000 square feet, is clearly at or very near the end of its useful life. Fiber degradation and loss through much of the playing surface is evident. This is particularly observable on the high wear areas of both soccer and softball with several areas of patching and worn-down zones to the carpet backing including much of the field striping and marking.

Some immediately adjacent features, such as fencing and dugouts, and supporting underground infrastructure are showing signs of age and wear. These features are close to presenting a hazard to users and should be corrected and/or repaired as part of the work.

1. Remove and replace the synthetic turf with similar long fiber infilled turf. A slightly higher density carpet is recommended to be used for the softball infield area increasing traffic tolerance and improved wearability. Selection of a non-rubber in-fill will be explored in-depth during the final planning and scope finalization design phase, is also recommended. The synthetic turf market and technology has matured in the last 12 years and better products are now common place for little to no premium.

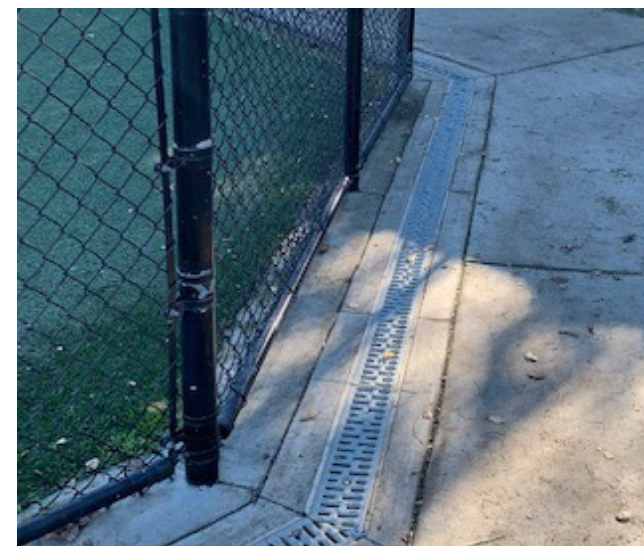
There is some good news. Our observation of the overall grade of the field is good; only a few localized spot grade repairs are forecast, and off-site draining corrections seemed to be adequate with only minor cleaning and flushing of the infrastructure necessary.

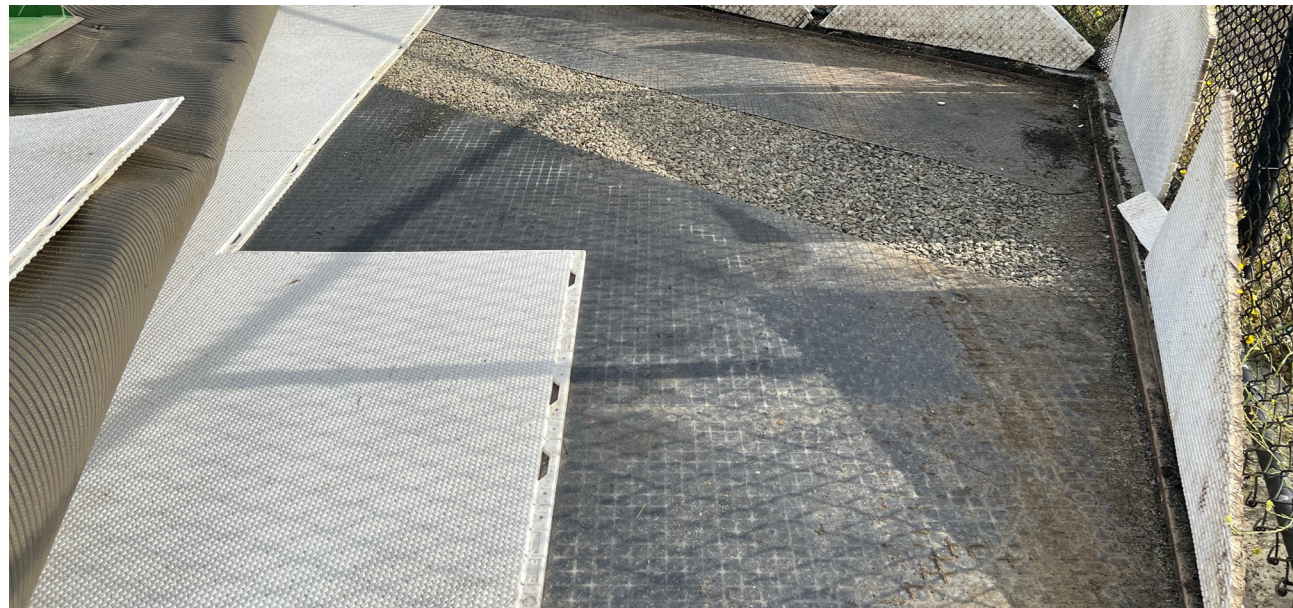
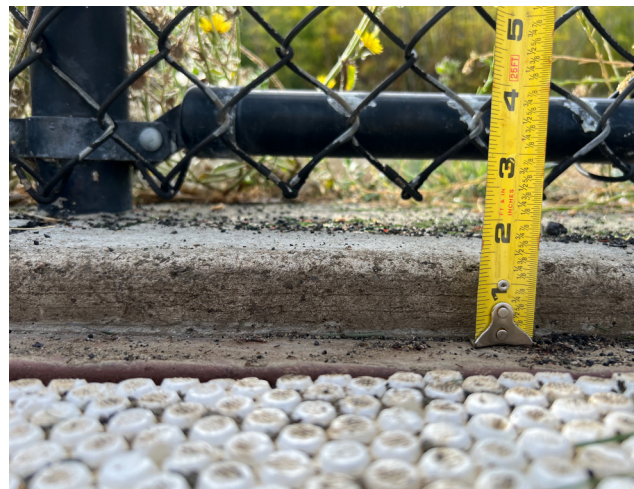
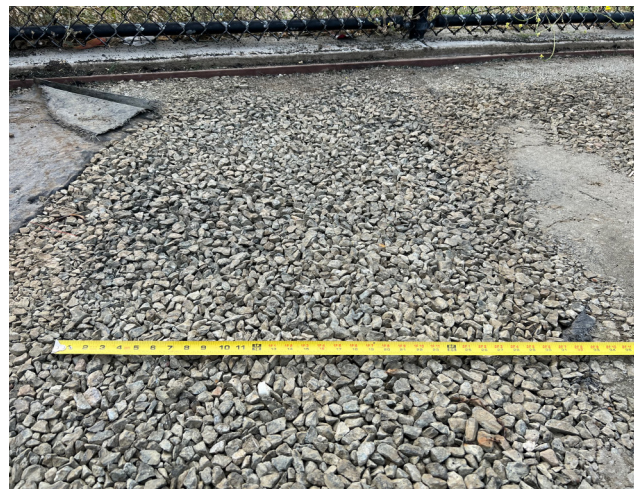
On Wednesday August 3rd, with the assistance of the District’s facilities team, Lloyd conducted a thorough review and examination of the playing fields surfacing system (turf, underlayment, fiber, and infill) and the supporting base (aggregates, edge detail, drainage, and underlayment). While different than the information contained in the record drawings provided, we encounter an apparently well executed sub surface drain, a fabric protected sub-grade, an intact shock attenuating/drainage layer, and little evidence of settlement and/or trans-location of materials (silts, clays, sand, and stone) under the field.

Our full report, [See Appendix B], revealed a solid and robust field construction that is likely to require very little rework and repair to the features and systems under the carpet.

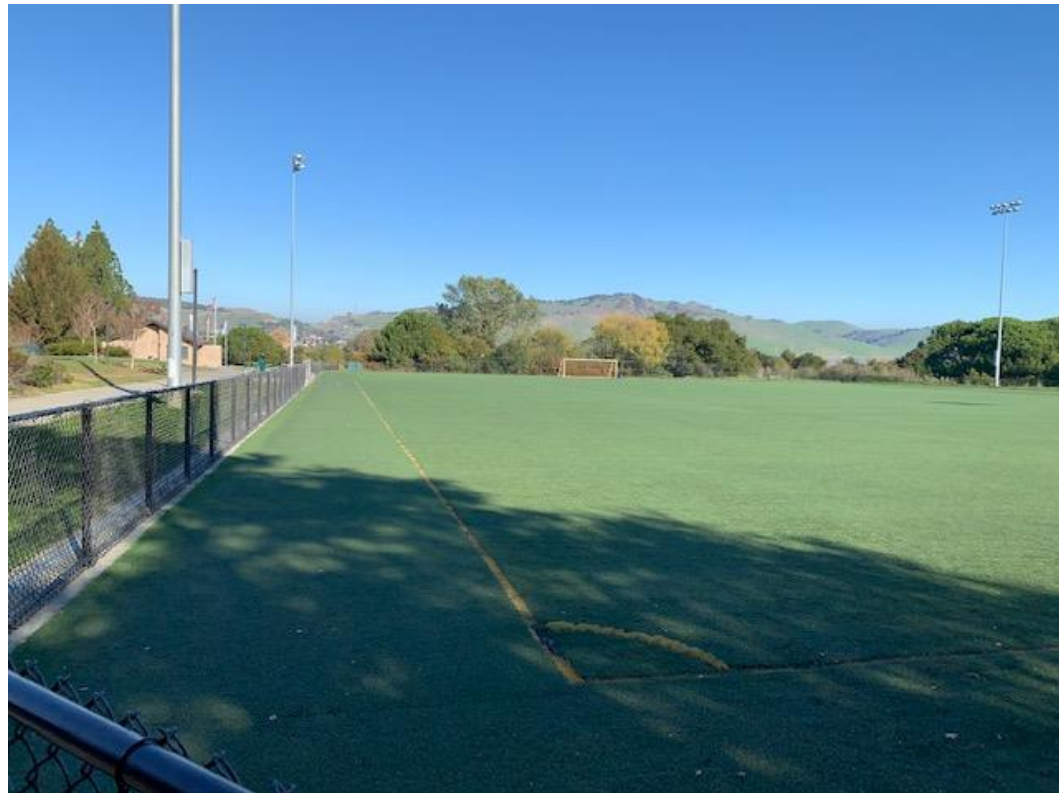
Photo 1 – Overview

1. The site was dry with no standing water on the field or adjacent landscapes.
2. The synthetic turf is at or very near the end its useful life with several obvious patches in high wear areas and a few minor spots where the turf has worn through to the backing and beyond.

3. The overall grade of the field was very uniform maintaining what appeared to be the original slope and features as designed.
4. The inlaid lines were straight, uniform, and very little waviness indicating settlement, shifting, and dislodging of materials under the turf surfacing had occurred since the original installation. A few localized minor depressions were visible on the surface, but no major settlement of any utility tranches or drain lines were evident.

5. Overall, from a surface observation the underlying structural base and associated underground infrastructure appears in good condition with no visible surface indications of major problems.

6. The venue is night lit and the field layout is a combined soccer and softball/youth baseball configuration.

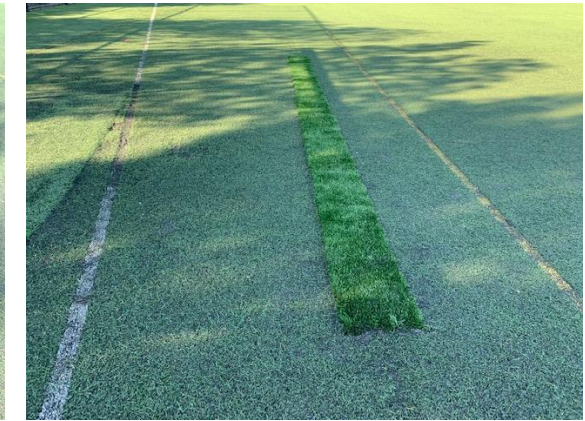
Photo 2 & 3 – Localized patches

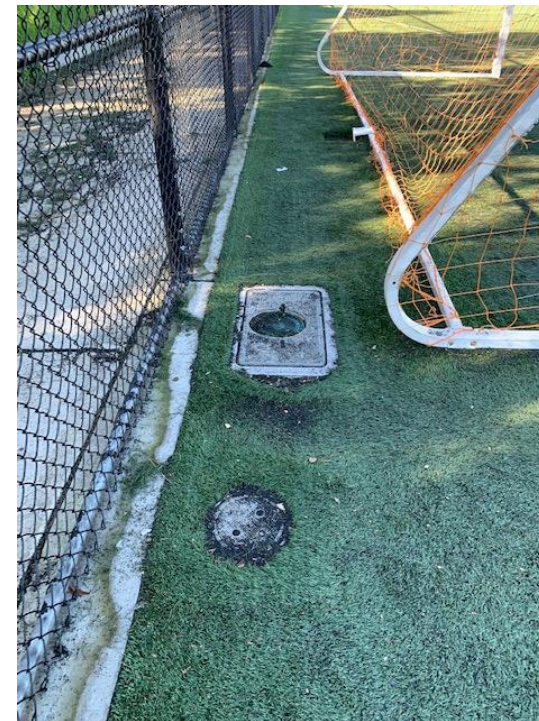
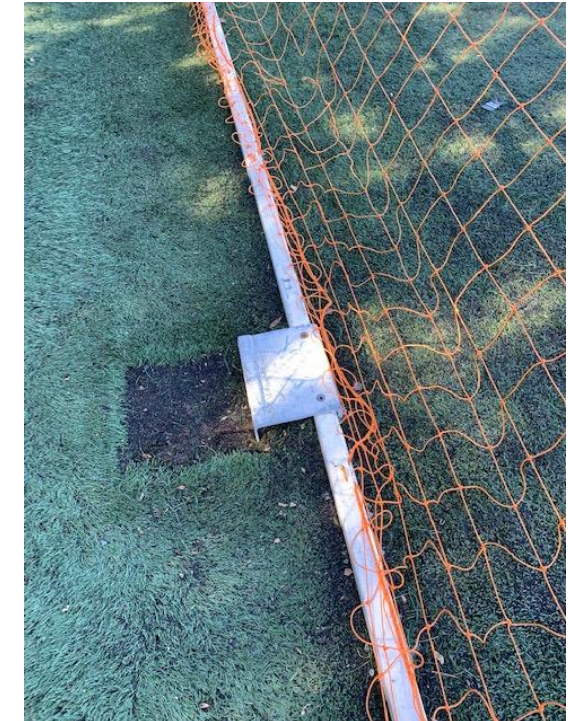
7. All of the surface utility features and boxes were reviewed, and some adjustments and local repairs will be needed, particularly around the in-ground water cannon irrigation systems should they be retained as part of the project.

Photo #4 & #5 – In-ground Utilities

2. Repair and modernize with new boxes and equipment the existing irrigation system including the pump station, irrigation works, and controls as needed.

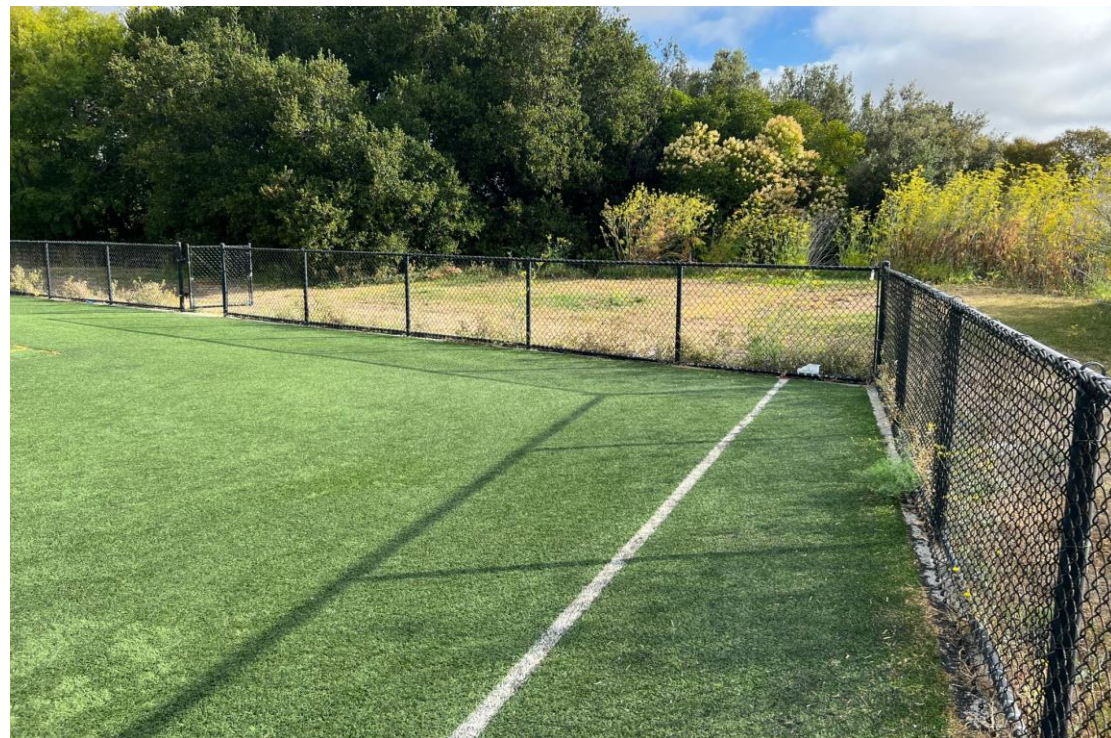
9. Lloyd and the District team then carefully conducted a subsurface investigation of the existing system and to conduct an ASTM F2898-11 Infiltration Test. The results and findings of that exploration are as follows:

Photo # 11 – Northeast Corner Selected for Investigation

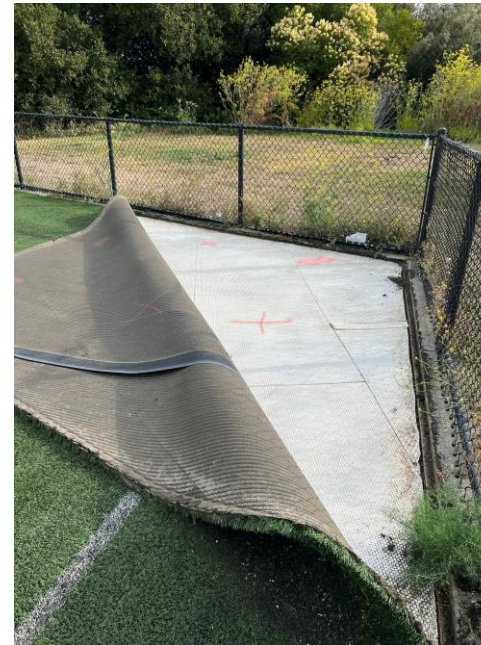
10. The carpet was carefully peeled back exposing the first layer of materials a white foam underlayment (Brock Power Base?). This material provides both shock attenuation for user safety and horizontal drainage just under the playing surface. The back of the turf was in good condition and indicated a FieldTurf product based on the manufacturing technique and wider tuft gauge.

Photo #12 – Underlayment

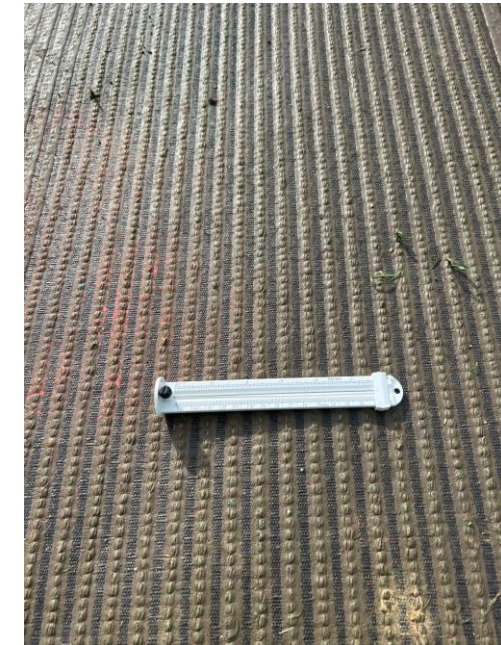
Photo # 11- Turf backing

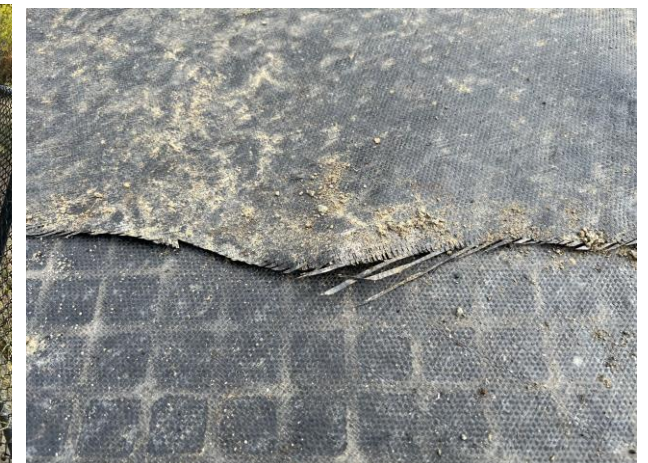
11. The underlayment was removed and revealed a base covered in a geofabric and an open stone infiltration drain trench filled with clean angular ¾” stone. The assembly was very clean and no obvious signs of settlement, or lateral movement of silt, sands, or soils. The 30” to 36” wide infiltration trench was in good condition. Upon rolling back the geofabric it revealed a second fabric that lined/wrapped the infiltration trench.

Photo # 13 – Geofabric Close-up

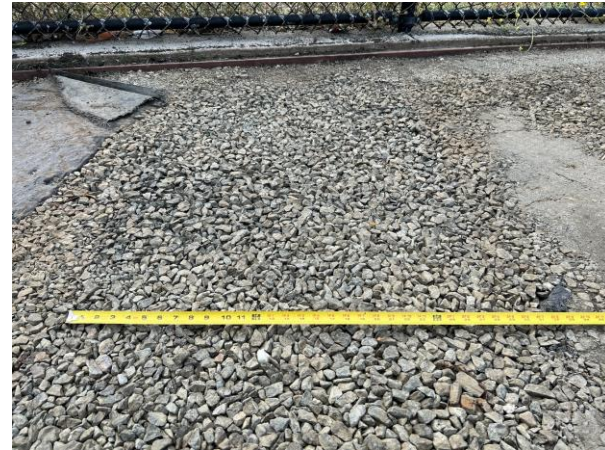
Photo #15 – Infiltration Trench

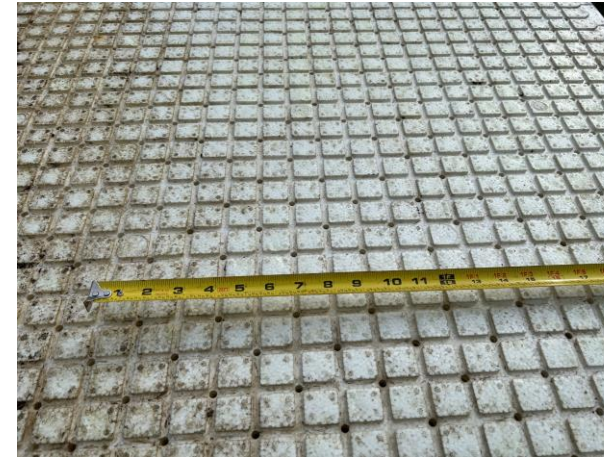
13. The underlayment is in fair condition and should withstand a resurfacing with only minor patch and repair after demolition of the turf. The product typical has a 20 - 25 year warranty.

Photo #14 – Bottom side of Underlayment

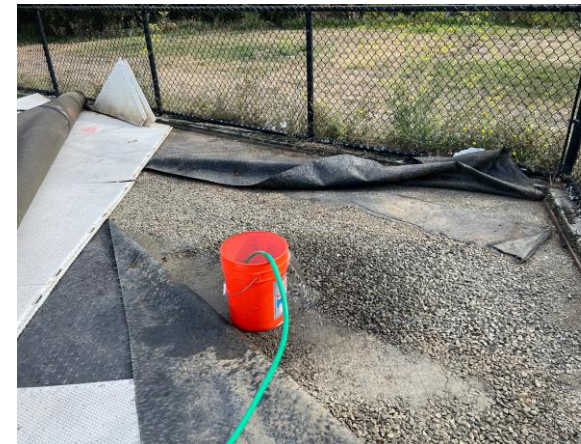
14. An unconfined infiltration test was conducted on the base at the rolled back flap located in the Northeast corner of the field. (ASTM F2898-11 test method was used). The **test was formally inconclusive** as water was moving vertically into the infiltration drain and data could not be collected from this location. A test atop the fabric layer would have likely shed water even quicker to the underground drain system.

Photo 13 – Start of Test on

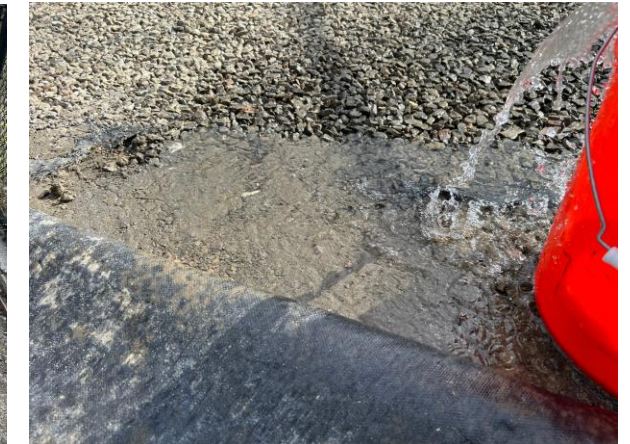
Photo 14 – Water Immediately draining
