Facility and Development Committee Agenda

2. Franklin Middle School Inspection Report

Commercial Inspection

Inspected on Fri, May 5 2023 at 11:17 AM

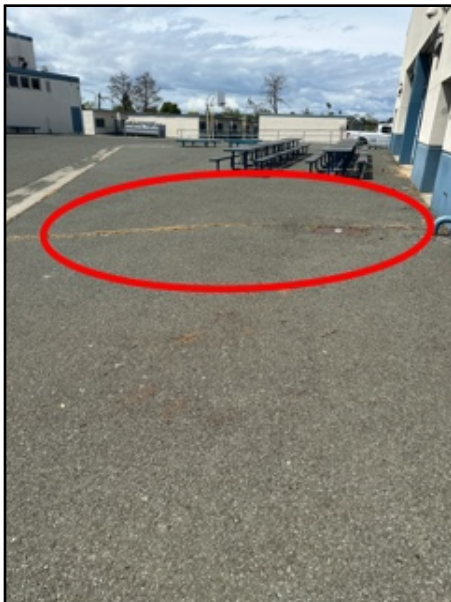
Figure 1-3

Walk ways have minor cracks and moisture entry points , around the perimeter,that can cause greater damage over time. Recommend licensed professional for repairs.

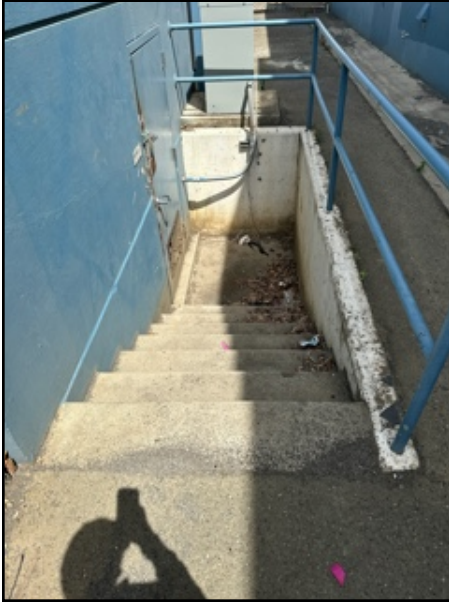
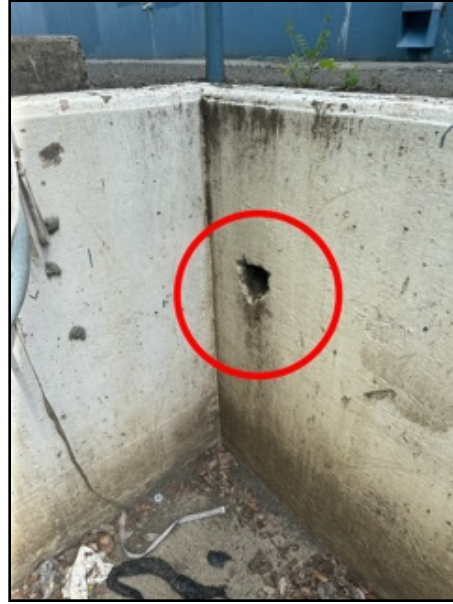
Comment 2:

Staircase that goes to the gymnasium storage room has a huge crater in the retaining wall near the storage room door. Recommend license, professional for repairs.

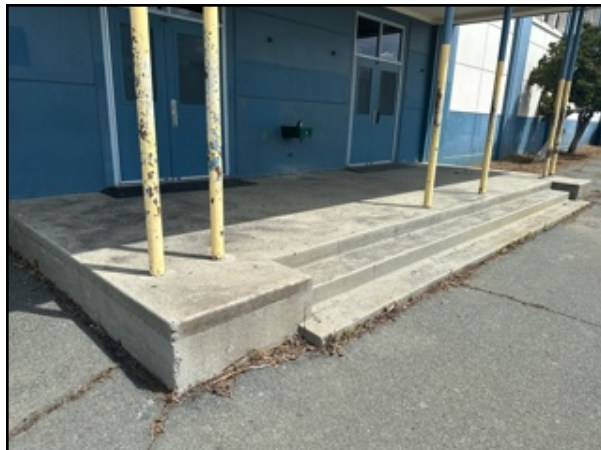
Concrete patio foundation has a horizontal crack from one into the other. Recommend a licensed professional for further evaluation and repairs to further extend the life expectancy of the concrete patio.

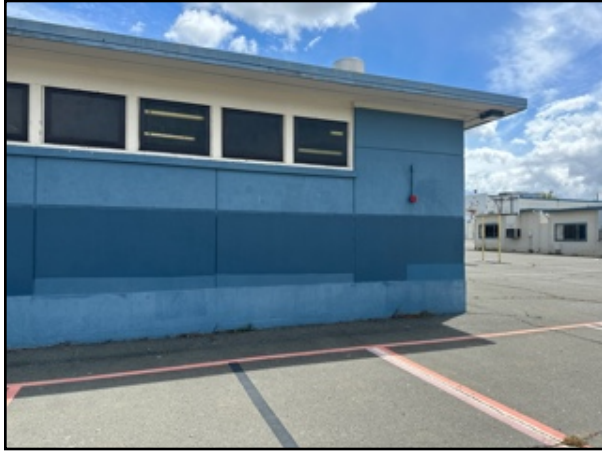
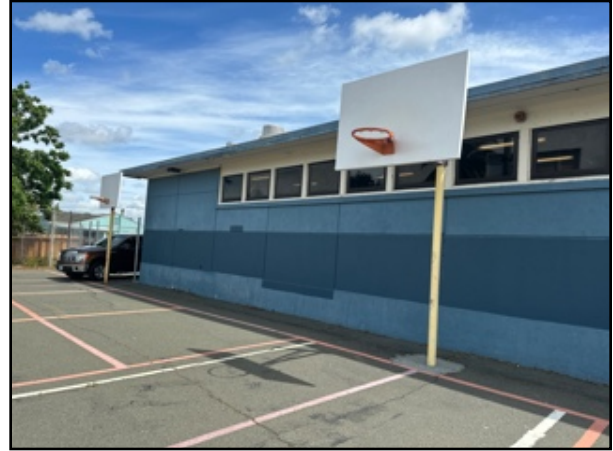
Comment 4:

Minor cracking and previous repairs made to cracks were observed. Recommend sealing and monitoring. If conditions worsen refer to structural engineer for further evaluation and remedy of repair

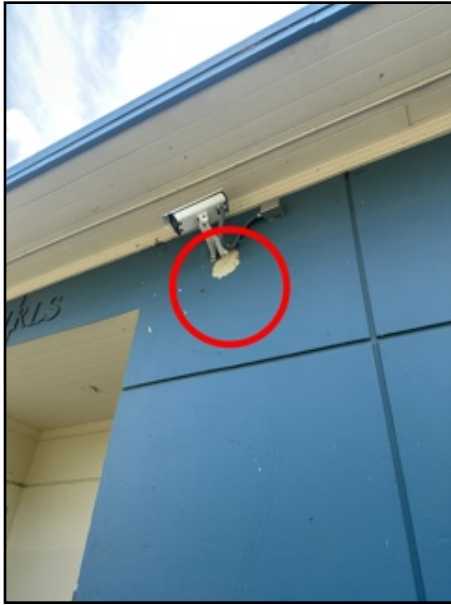
Figure 5-3

Some areas have lost paint over time. Recommend licensed painter for painting to ensure longevity.

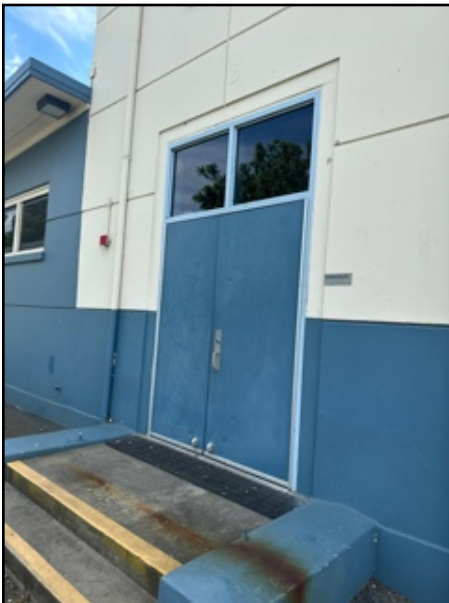
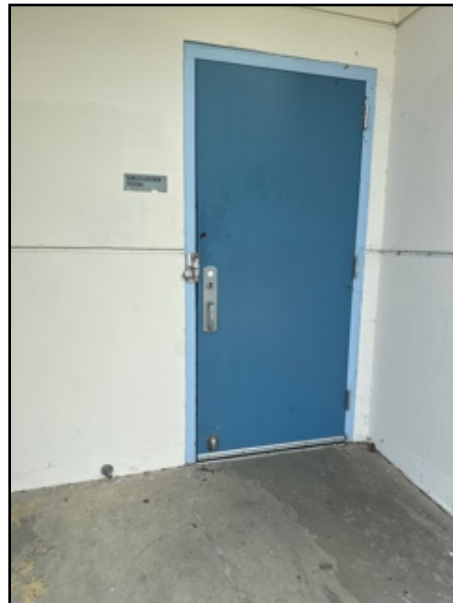
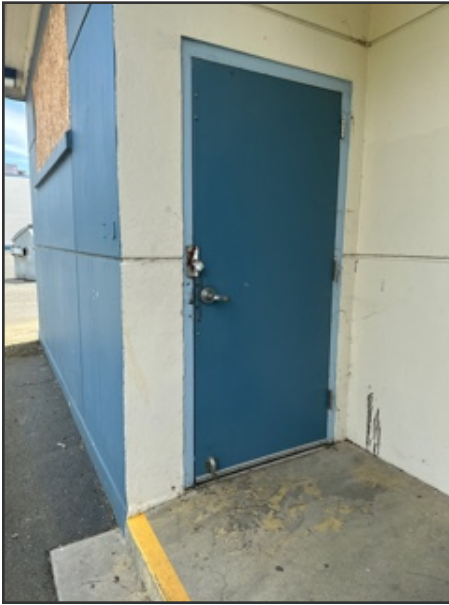
Comment 10:

Weatherstrip bar on the base of some of the gymnasium steel doors are damaged. Recommend licensed professional for repairs and replacement.

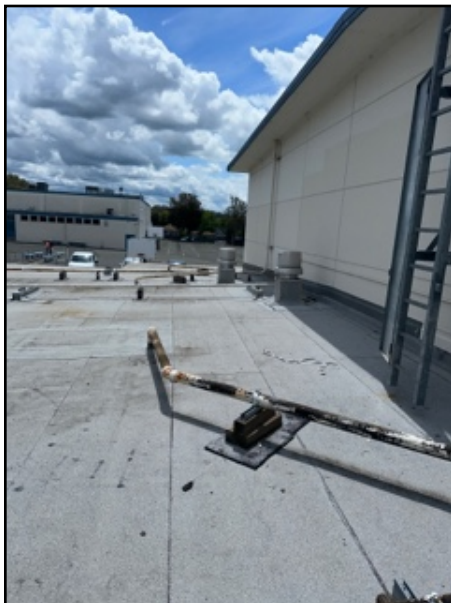
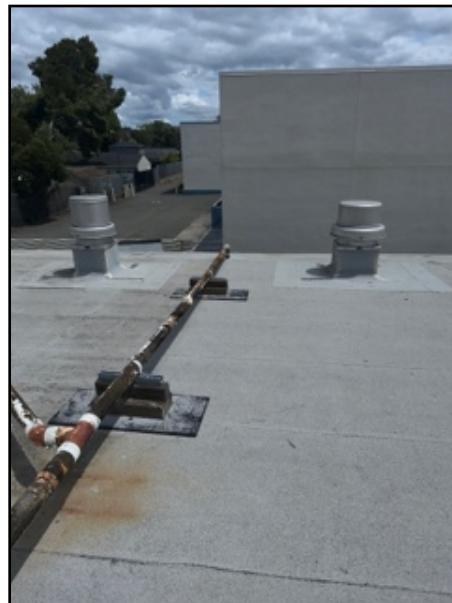
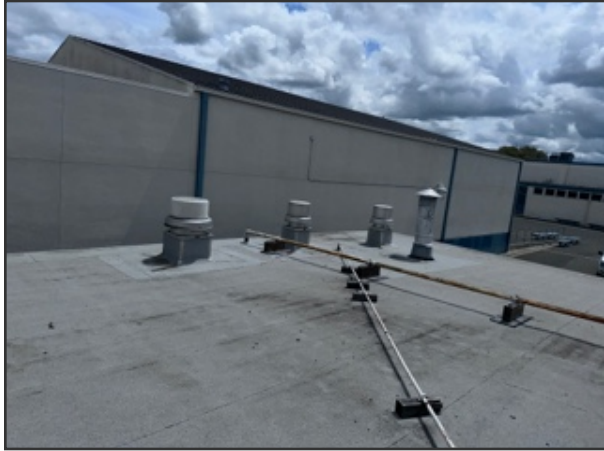
Comment 12:

Vent stack on the roof on the right side of the building has bullet holes riddled through it. Recommend a licensed professional for replacement .

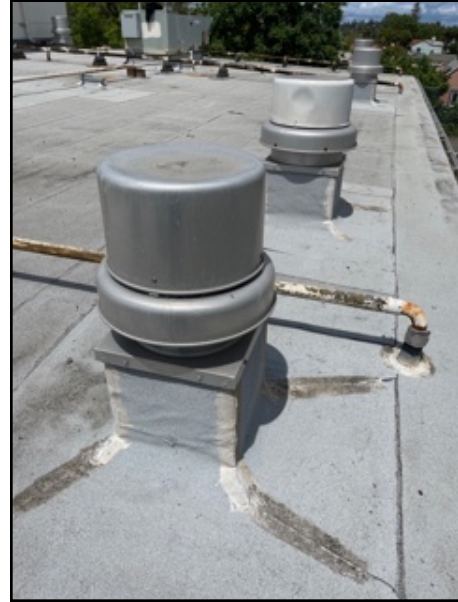
Figure 14-2

Flashing cracked and not sealed around vents/stack/siding. Recommend a licensed professional to perform general roof maintenance.

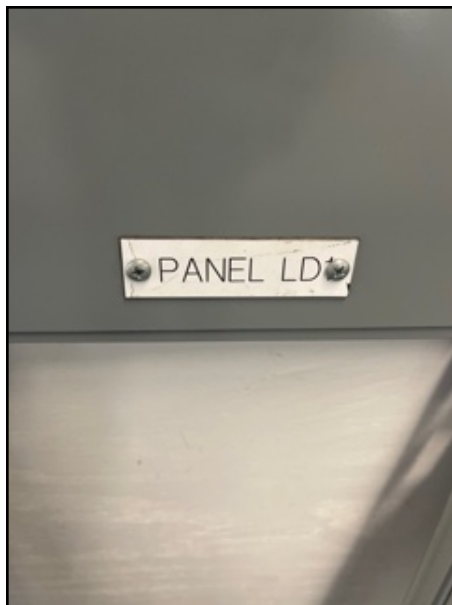
Figure 17-1

Comment 17:
Panel LD.

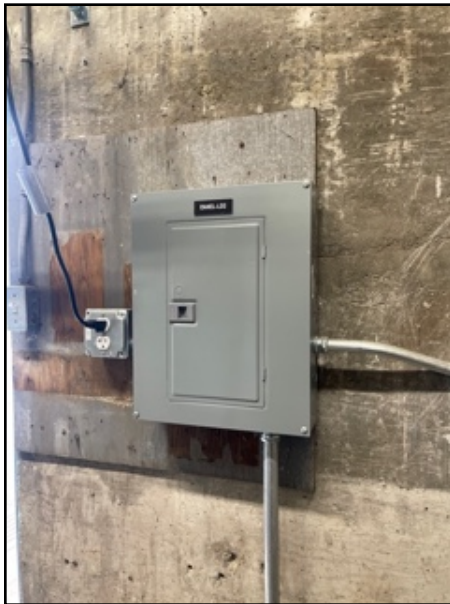
Figure 18-1

Comment 18:
Panel LD2.

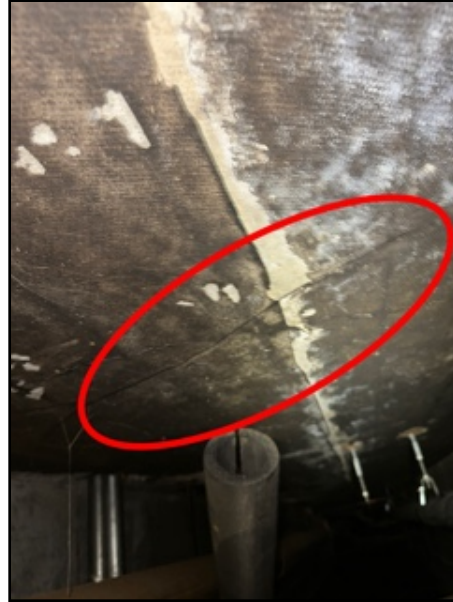
Figure 22-2

Plumbing Corridor ceiling has multiple cracks throughout the base of the concrete slab. Recommend structure waiting to hear for further evaluation.

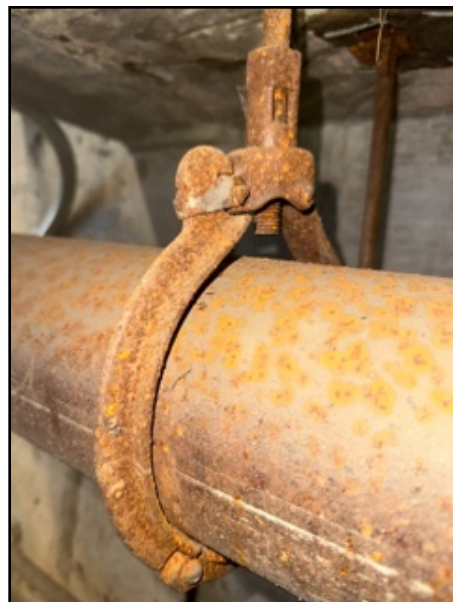
Figure 23-2

Pipeline mounts are rusted ,corroded and some are cracked. Recommend license, professional for repairs and replacement.

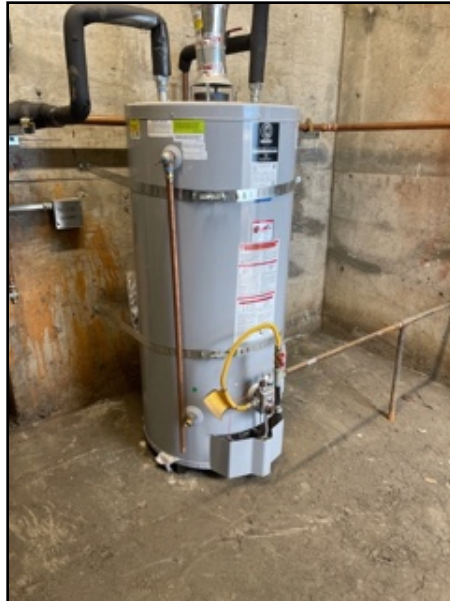
Water heater not functioning at time of inspection. Pilot light was not lit

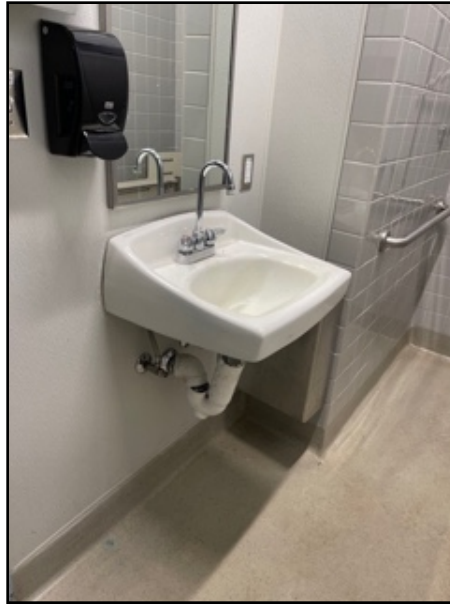
Comment 27:

Sink continuously runs when not in use. Sink is loose against wall. Recommend repair

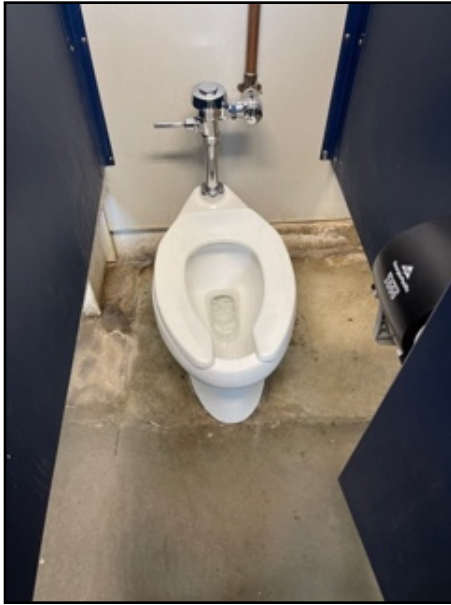
Figure 30-3

Toilet is loose. Recommend resealing/fixing toilet to flooring. This will prevent moisture access points and damages to wax seal while operating

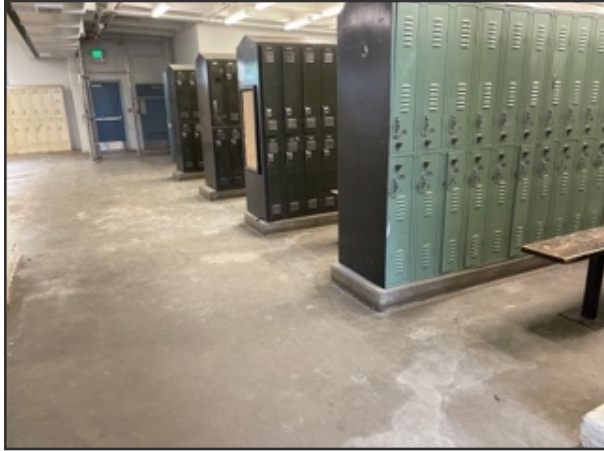
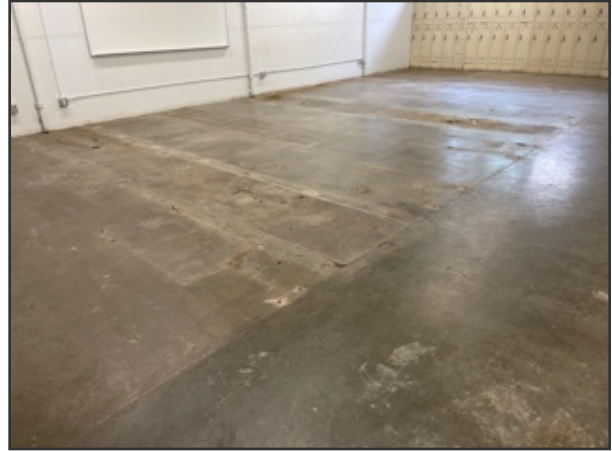
Comment 32:

Minor cracking observed at floor/floor slab. Recommend monitoring carefully. If conditions worsen refer to a structural engineer for further evaluation

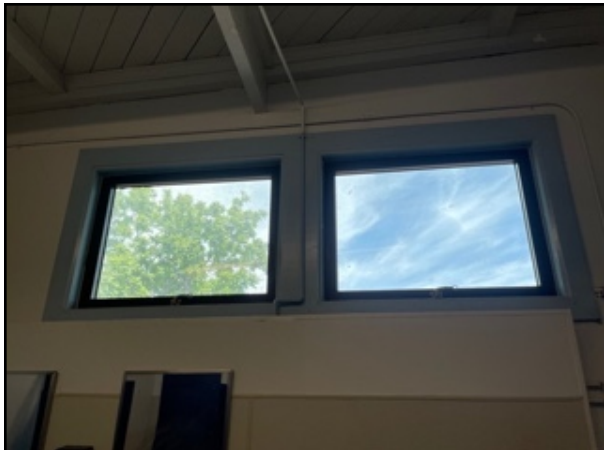
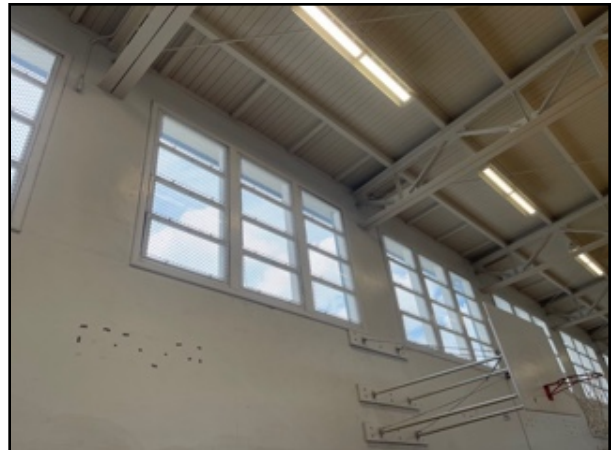
Comment 35:
Wood rot located on multiple window framings near basketball court.
Recommend removal and replacement

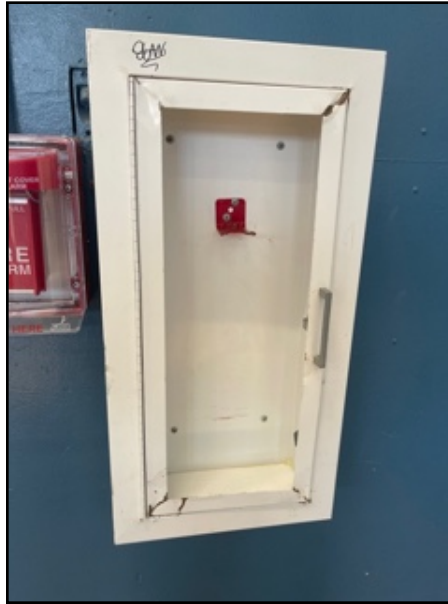
Fire Extinguishers:

Not Present

Comment 37:

Recommend installing and regular servicing and maintenance of extinguishers to ensure they're working properly in the case of an emergency.

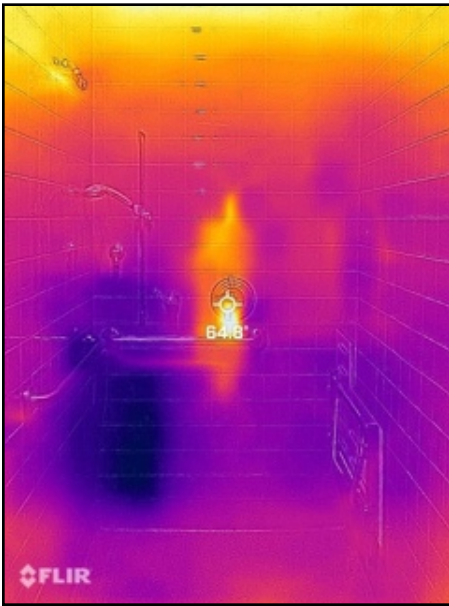
Figure 38-1

Comment 38:
Interior photos .
